Larrabee & Associates, Inc.

Property Address:
668 W. Washington Avenue
Sunnyvale CA 94086

Date: 8/4/2017	Time:	Report ID: 17_08_02
Property: 668 W. Washington Avenue Sunnyvale CA 94086	Customer: Kathleen D'Silva	Real Estate Professional: Dave Clark

This documentation confirms that Larrabee & Associates, Inc. (LAI) Consulting Services Division has completed our evaluation at 668 W Washington Ave., Sunnyvale, CA 94086 on Tuesday, August 1, 2017 as requested by Dave Clark, acting representative for Kathleen D'Silva.

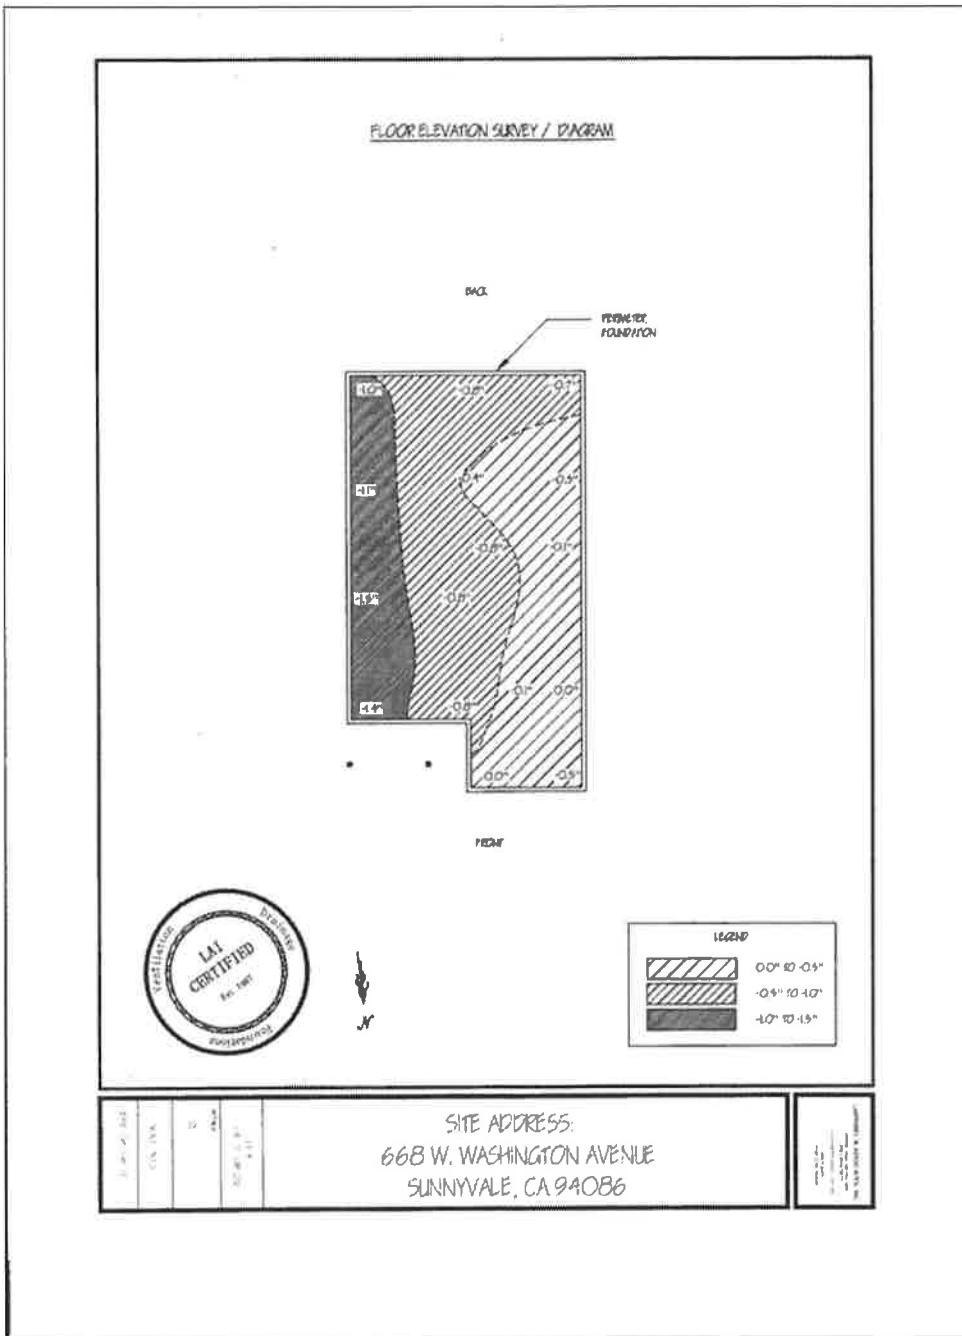
3.0 Item 1(Picture)

Observation: A digital water level survey was conducted on the interior finished floor surfaces to help determine the performance of the perimeter foundation and interior support assemblies in relation to the building pad. The results of the survey indicated that the finish floor planes are generally within normally acceptable tolerances and, in our opinion, an indication of good overall foundation performance when compared to similar foundation systems in the general area. See the attached floor elevation survey with approximate measurements compared to the highest recorded elevation marked as 0.0". Item 1(Picture)

Information: Industry standards consider floor variations up to 1" over a 20' segment as a reasonable maximum differential for general foundation performance and within normally acceptable levels.

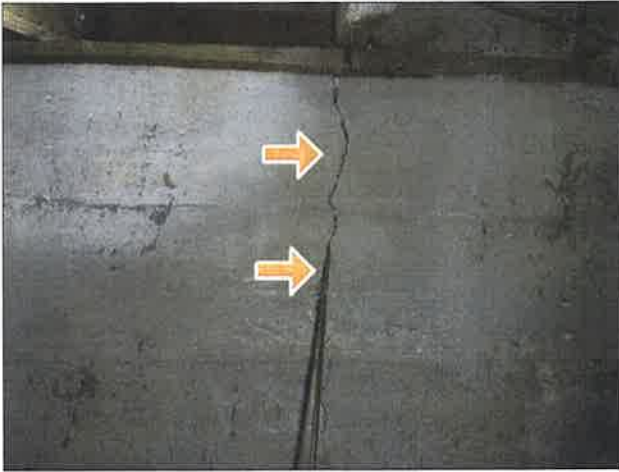
4.0 Item 1(Picture)

Observation: Approximately (8) minor to moderate vertical fractures noted in the perimeter foundation stemwall. Item 1(Picture)

Information: Some levels of fracturing are not unusual for structures of this age. The observed fracture sites indicate past stresses (i.e. seismic activity, poorly controlled drainage conditions, outside forces, etc.) in the affected foundation sections.

Recommendation (04.00.04) - Implement appropriate reinforcement procedures, materials and / or hardware to help improve attachment, preserve embedded steel (where applicable), establish more uniform performance and load characteristics at foundation fracture sites, as well as create a monitoring band for monitoring for any future movement. In this case, retrofit details should include epoxy injection. ***Anticipate costs in the vicinity of \$3,200.***

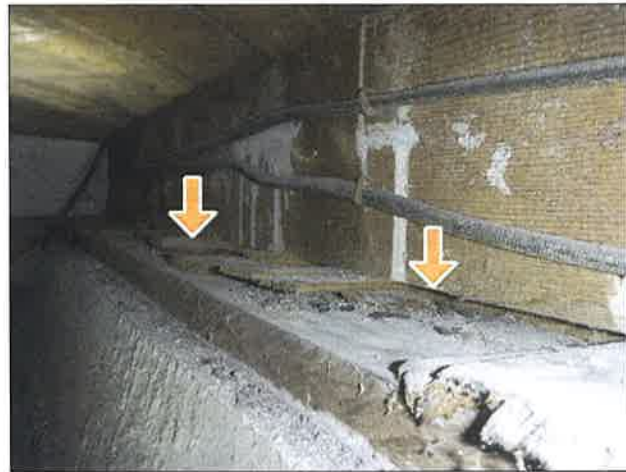
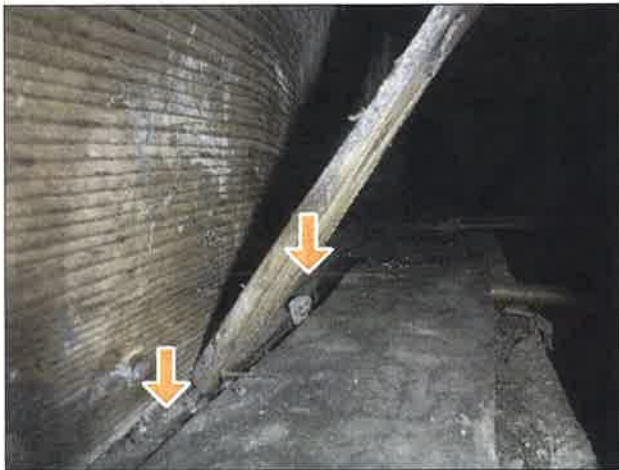
Observation: A small section (est. 2') of the mudsill detail along the back of the crawlspace, adjacent to the crawlspace entryway, appeared to be split. In addition, the rim joist adjacent to the front of the crawlspace was shimmed, apparently from original construction practices. Both conditions are somewhat common for many foundation systems built during this era of construction. Item 2(Picture) Item 3(Picture)

Information: The sill plate (mudsill) / rimjoist acts as a connecting mechanism providing attachment between the structure and the perimeter foundation system. Its purpose is to evenly distribute loads onto the perimeter foundation system and to offer necessary attachment between the structure & foundation. Any modification to the attachment and/or loading properties subjects the structure to potential displacement under seismic / heavy weather loads.

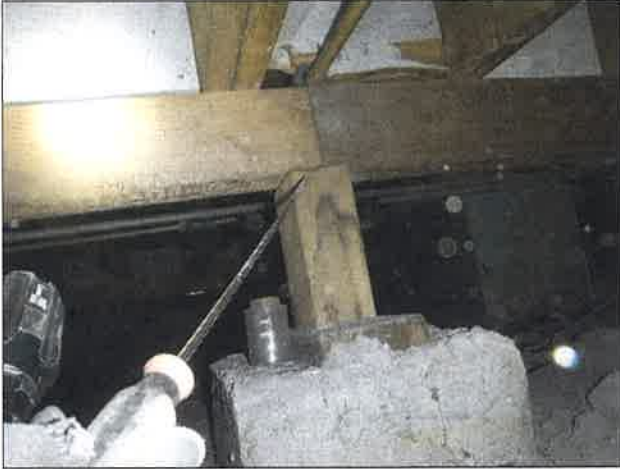
4.2 Item 1(Picture)

Observation: The interior isolated concrete piers and wooden support posts appear to be in serviceable condition. Item 1(Picture)

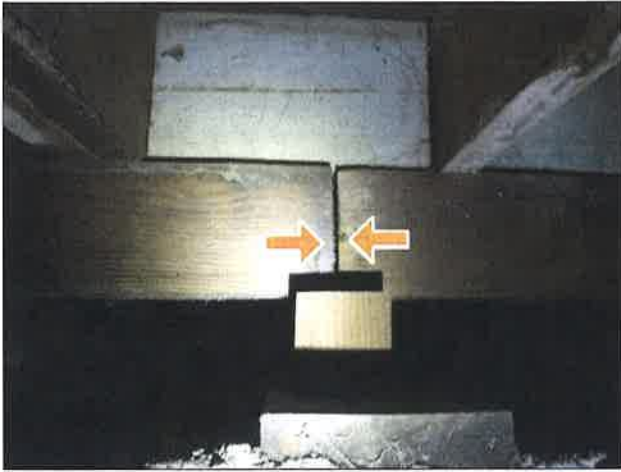
4.3 Item 1(Picture)

Observation: The girder system appears to be in serviceable condition. However, we did note regionally spliced girders without positive attachment (typical of age). Item 1(Picture)

Recommendation (04.03.05) - Installation of 2x6 wood members across spliced locations. ***Anticipate costs in the vicinity of \$1,500***

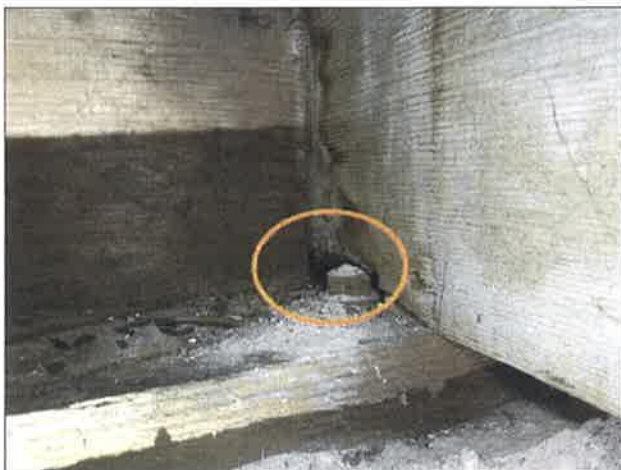
4.5 Item 1(Picture)

Observation: The perimeter foundation contains anchor bolt attachment hardware. Item 1(Picture)

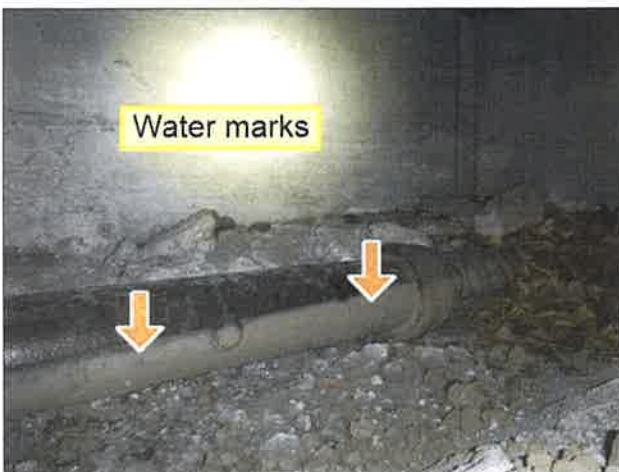
4.7 Item 1(Picture)

Observation: The crawlspace was relatively dry at the time of our evaluation. However, we did note evidence of possible low-level seasonal moisture intrusion and accumulation at the front right of the crawlspace. Item 1(Picture)

Recommendation - Implement strict controls on moisture sources adjacent the perimeter foundation system. Refer to the Exterior drainage recommendations and the "Surface Moisture Control Advisory" at the end of this report. Specifically, refer to roof gutter installation, downspout management, and grading of surfaces adjacent to the perimeter foundation.
