## ROOFING INSPECTION REPORT

### **INSPECTION DATE**

30-Sep-08 11:00 am to 1:30 pm

## GENERAL INFORMATION

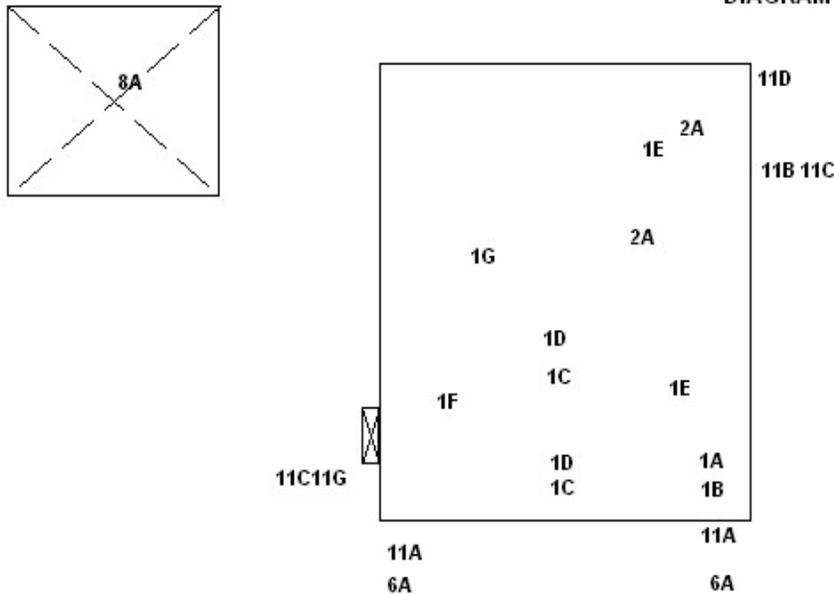
DIAGRAM NOT TO SCALE

ITEM 11A FINDING: Rot damage was noted to the rafter tails at area indicated on the diagram.

ITEM 11C FINDING: Evidence of Drywood Termites were noted at the exterior at the area indicated on the diagram.

ITEM 11D FINDING: Fungus damage was noted to the 2x6 fascia at the area indicated on the diagram.

RECOMMENDATION: Remove and replace the damaged rafter tails. Should damage extend further or into inaccessible areas, a supplemental report will be issued outlining findings and additional repair costs. Roof coverings may have to be removed in order to facilitate repairs. Owner to paint.

RECOMMENDATION: See recommendation in item #1A above regarding fumigation of entire structure.

RECOMMENDATION: Remove and replace with new materials. Other trades to paint upon completion of repairs.

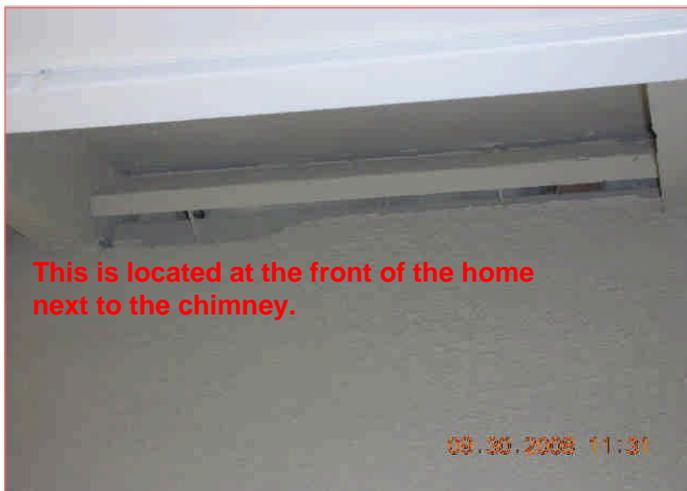
- v 2.16 - Section of the trim have not been installed properly. All joints in the material should be properly sealed to prevent water penetration.

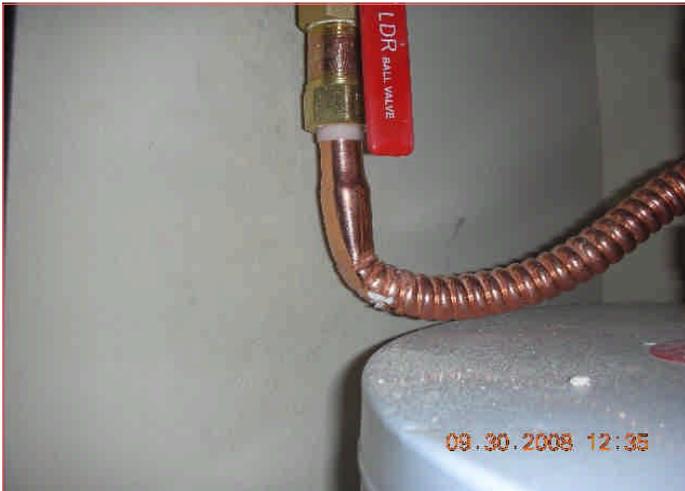
- √ 4.12 - The flexible pipe connected to the water heater is crushed/pinched. This can lead to low water pressure. This also increases the possibility of leaking pipes.

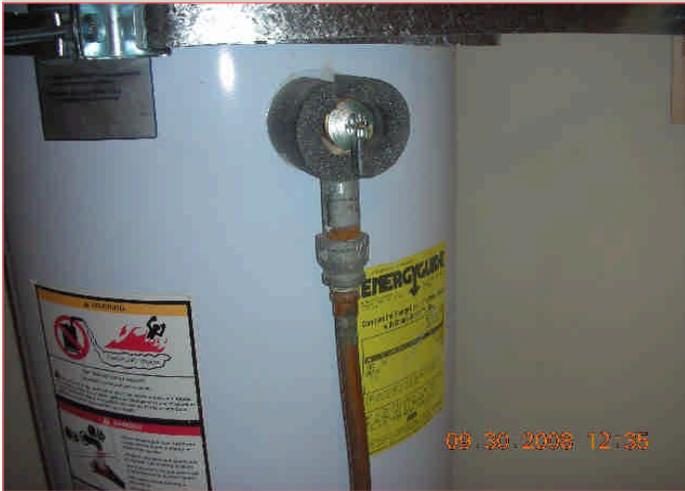
- ✓ 4.17 - The discharge pipe from the pressure relief valve should be plumbed so that the pipe does not reduce in size. The pressure relief valve is threaded to accept 3/4 inch pipe.

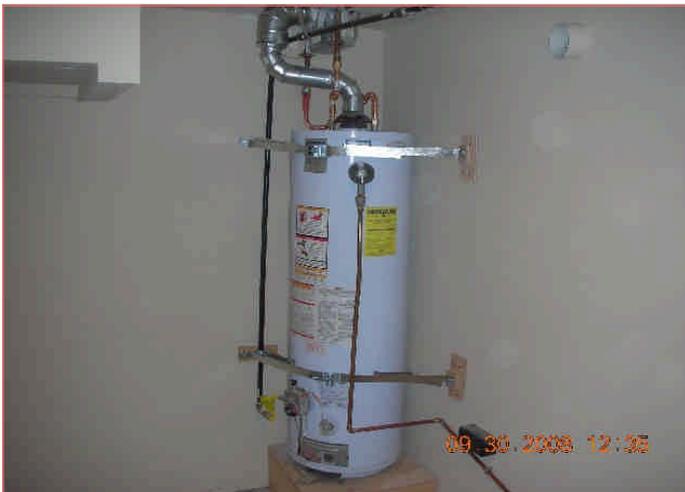
- ✓ 4.20 - Water heaters in seismic zones should be anchored or strapped (with a strap designed for water heaters) to resist movement during earthquake conditions. The water heater should not be able to move. The straps should be 1/3rd of the length from the top and bottom.

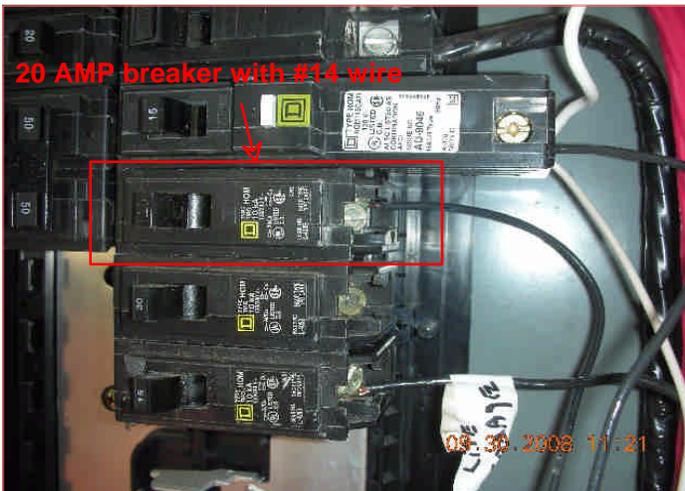
- √ 5.7 - A twenty-amp breaker is serving undersized, or number fourteen wires, which is a fire-hazard that should be corrected by an electrician.
