# WOOD DESTROYING PESTS AND ORGANISMS INSPECTION REPORT

Building #, Street, City, State, Zip <b>717 W. Fremont Avenue, Sunnyvale, CA 94087</b>	Date of Inspection <b>3/16/2021</b>	# Pages <b>11</b>
---	--	----------------------

**Report #: 63088**

General Description: <b>TWO STORY CONDOMINIUM WITH WOOD FRAME AND STUCCO/WOOD EXTERIOR. LIMITED TO THE INTERIOR/STORAGE AND HEATER CLOSET OF UNIT #717 ONLY.</b>	Inspection Tag Posted: <b>UNDER KITCHEN SINK</b>
	Other Tag(s) Posted: <b>HOMEGUARD 2019</b>

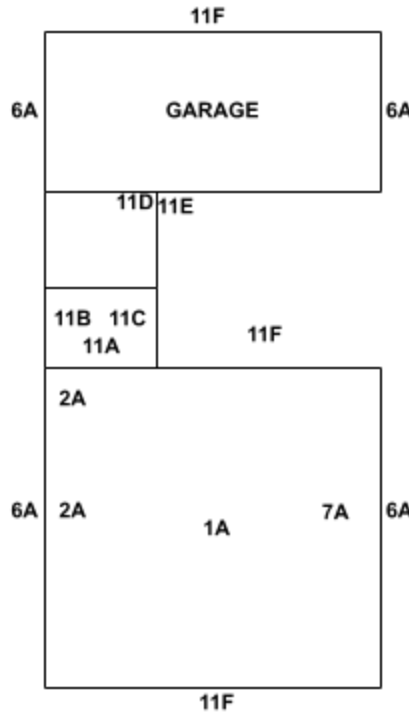
**DIAGRAM NOT TO SCALE**

An inspection has been made to the structure(s) shown on the diagram in accordance with the Structural Pest Control Act. Detached porches, detached steps, detached decks and any other structures not on the diagram were not inspected.
