Assurance Home Inspection, Inc.
661-A East D Street
Dixon, CA 95620
408-600-5958
Inspection Date: April 6, 2021

477 S. Taaffe St Sunnyvale

Paul Reed
477 S. Taaffe St Sunnyvale CA 94086
Page 1 of 16

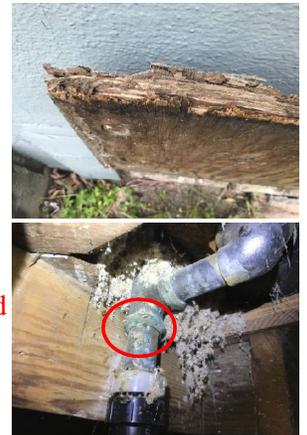
9. **Crawl Space Drainage Piping:** Based on what was visible, the drainage piping within the crawlspace appears to be cast iron, galvanized piping and ABS plastic. There is evidence of present leakage at the drain pipe union below the tub. It is recommended that a competent licensed plumbing contractor be consulted to further evaluate for the presence of any extended conditions than what is noted, for recommendations and corrective work.
