WOOD DESTROYING PESTS AND ORGANISMS INSPECTION REPORT

| Building #, Street, City, State, Zip 794 Londonderry Drive, Sunnyvale, CA 94087 | Date of Inspection 3/25/2021 | # Pages 12 |

ANTIQUE TERMITE, INC.

| General Description: ONE STORY SINGLE FAMILY DWELLING WITH WOOD FRAME AND STUCCO/BRICK EXTERIOR | Inspection Tag Posted: GARAGE |

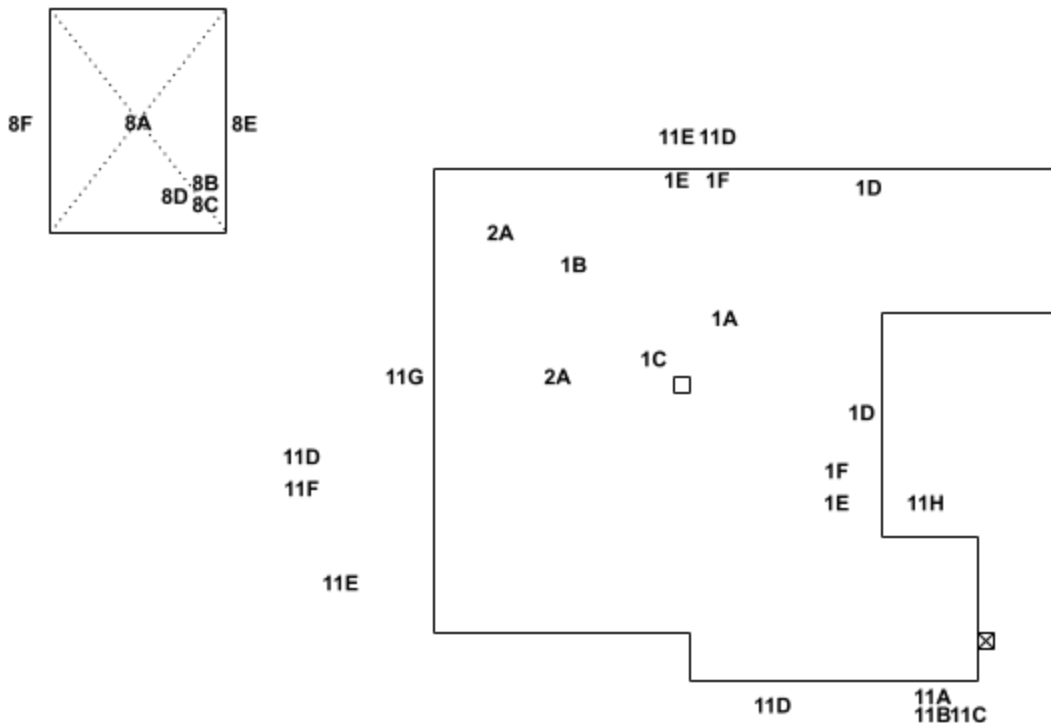
DIAGRAM NOT TO SCALE

ITEM 1E FINDING: Evidence of infestation by drywood termites was noted at the subarea in the area indicated on the diagram. These infestations appear to extend into inaccessible areas.

ITEM 8B FINDING: Drywood termite damage was noted to the studs in the area indicated on the diagram.

ITEM 8C FINDING: Evidence of infestation by drywood termites was noted at the detached garage in the area indicated on the diagram. These infestations appear to extend into inaccessible areas.

ITEM 8F FINDING: There is a O lot line where indicated on the diagram. This area is considered inaccessible for inspection.

ITEM 11A FINDING: Drywood termite damage was noted to the rafter tails in the area indicated on the diagram.

ITEM 11B FINDING: Evidence of drywood termites was noted at the exterior area indicated on the diagram.

RECOMMENDATION: Owner to seal and maintain the stucco cracks in the areas indicated on the diagram.

SECTION I FUMIGATION RECOMMENDATION: Seal up and fumigate the entire structure with a lethal gas (VIKANE/SULFURYL FLUORIDE AND CHLOROPICRIN) for the control of drywood termites in all areas of the structure. Remove the seals for reoccupancy.

SECTION I RECOMMENDATION: Remove and replace these damaged studs with new material. Owner to
WOOD REPAIR contact other trades to paint.

SECTION I
WOOD REPAIR RECOMMENDATION: Remove and replace the damaged rafter tails in this area. Owner to contact other trades to paint.
